MERRIMACK RIVER BASIN
NELSON, NEW HAMPSHIRE

NUBANUSIT LAKE DAM

NH 00339

PHASE I INSPECTION REPORT
NATIONAL DAM INSPECTION PROGRAM

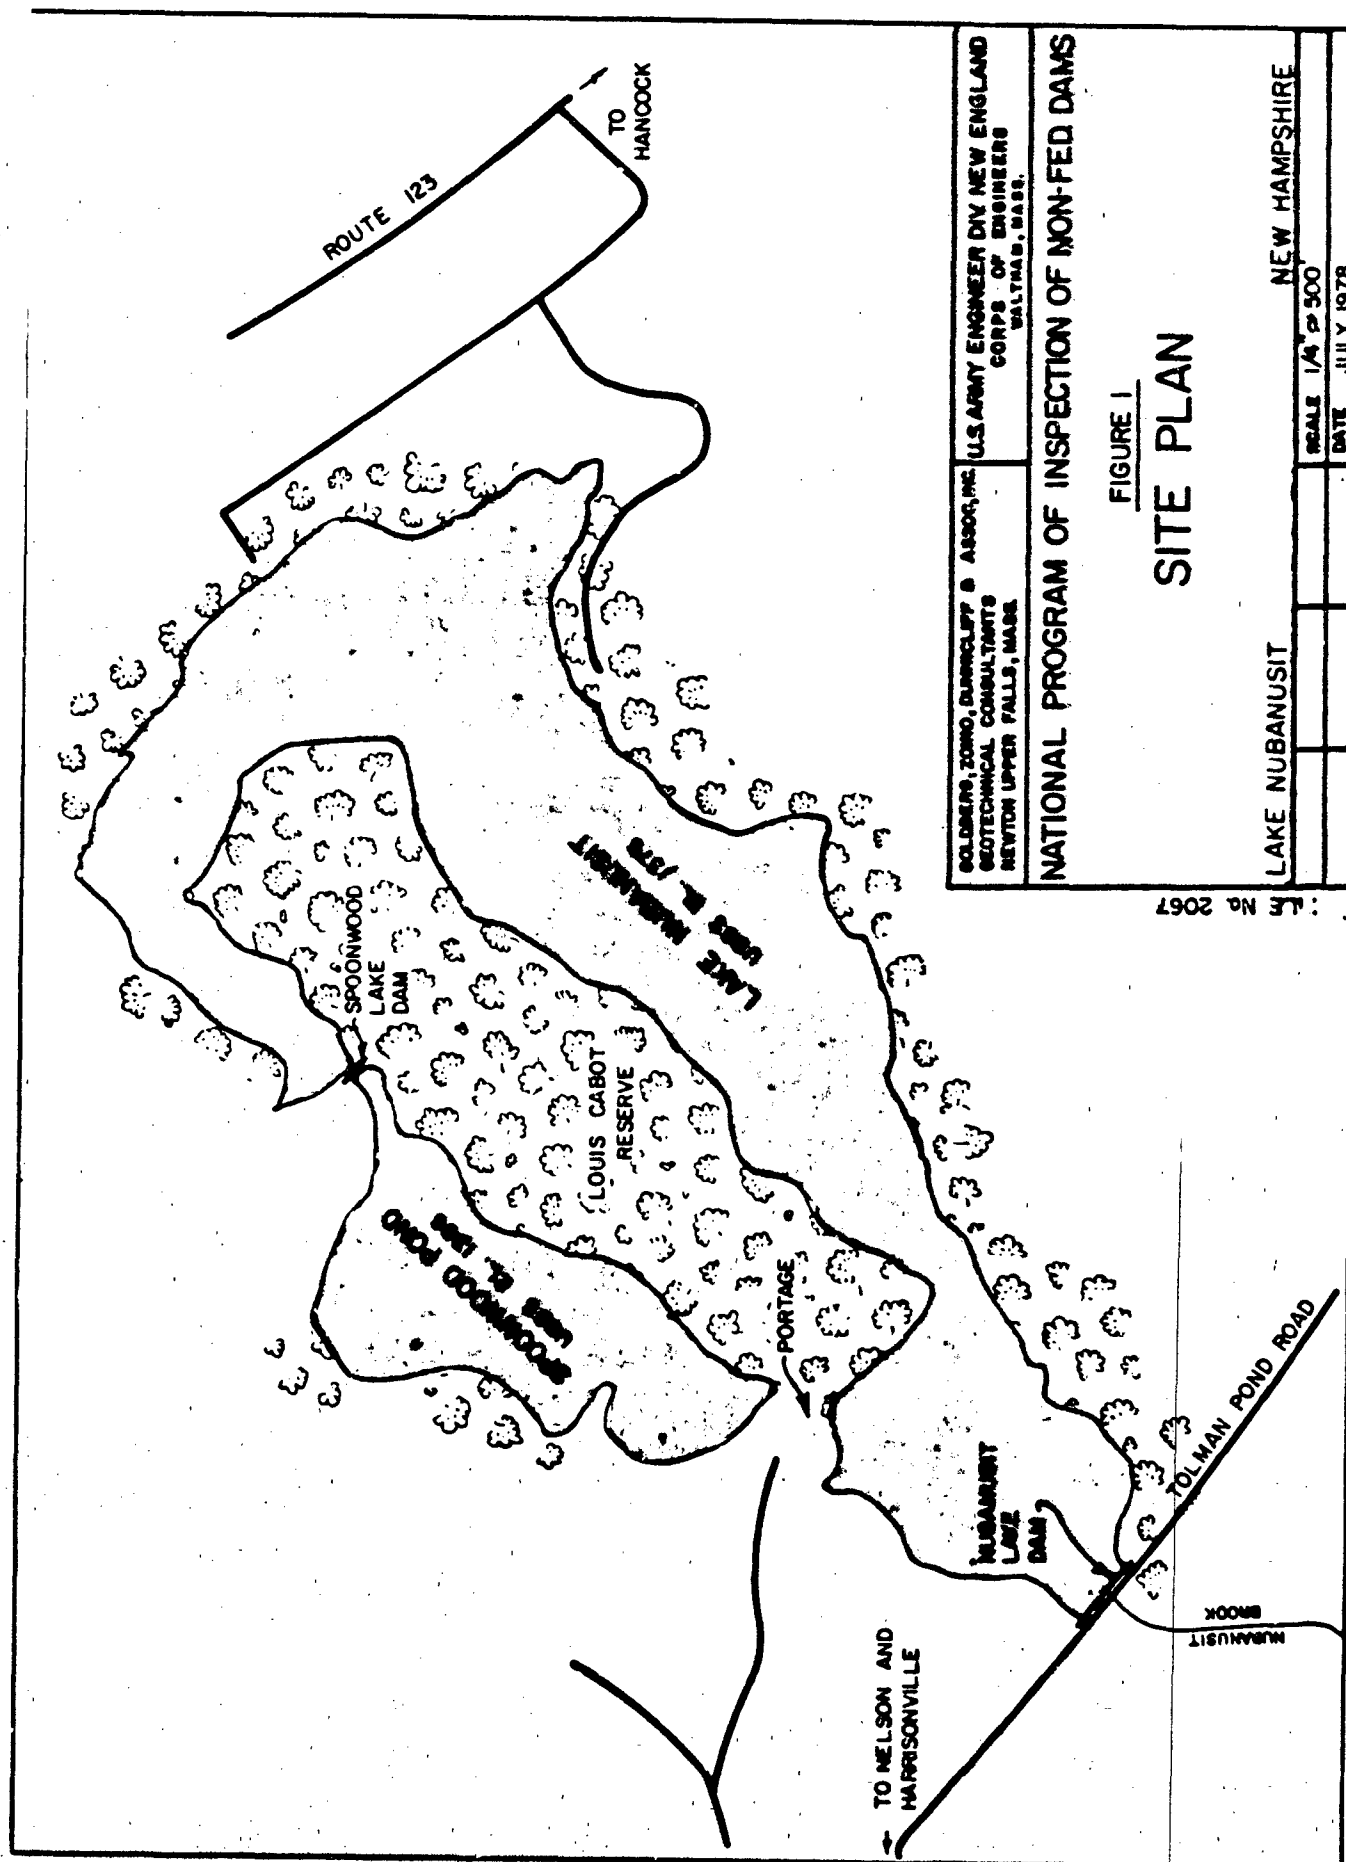
This dam lies in the Merrimack River Basin at the southwest end of Nubanusit Lake, approximately 2 miles north of the town of Harrisville. Access to the site is via Tolman Pond Road which intersects Nelson Road 0.3 miles south of the town of Nelson. The portion of the USGS Moradnock, N. H. quadrangle presented previously shows this locus. Figure 1 of Appendix B presents a detail of the site developed from the USGS map and the site inspection.

The dam has no formal appurtenant structures. The nearby Spoonwood Pond Dam, however, discharges directly into Nubanusit Lake and, therefore, influences the hydrology of the lower lake (Fig. 1). Although Section 5 of this report briefly discusses the influence of the Spoonwood Dam on Nubanusit Lake, the condition of the structure is the subject of a separate report under this contract.

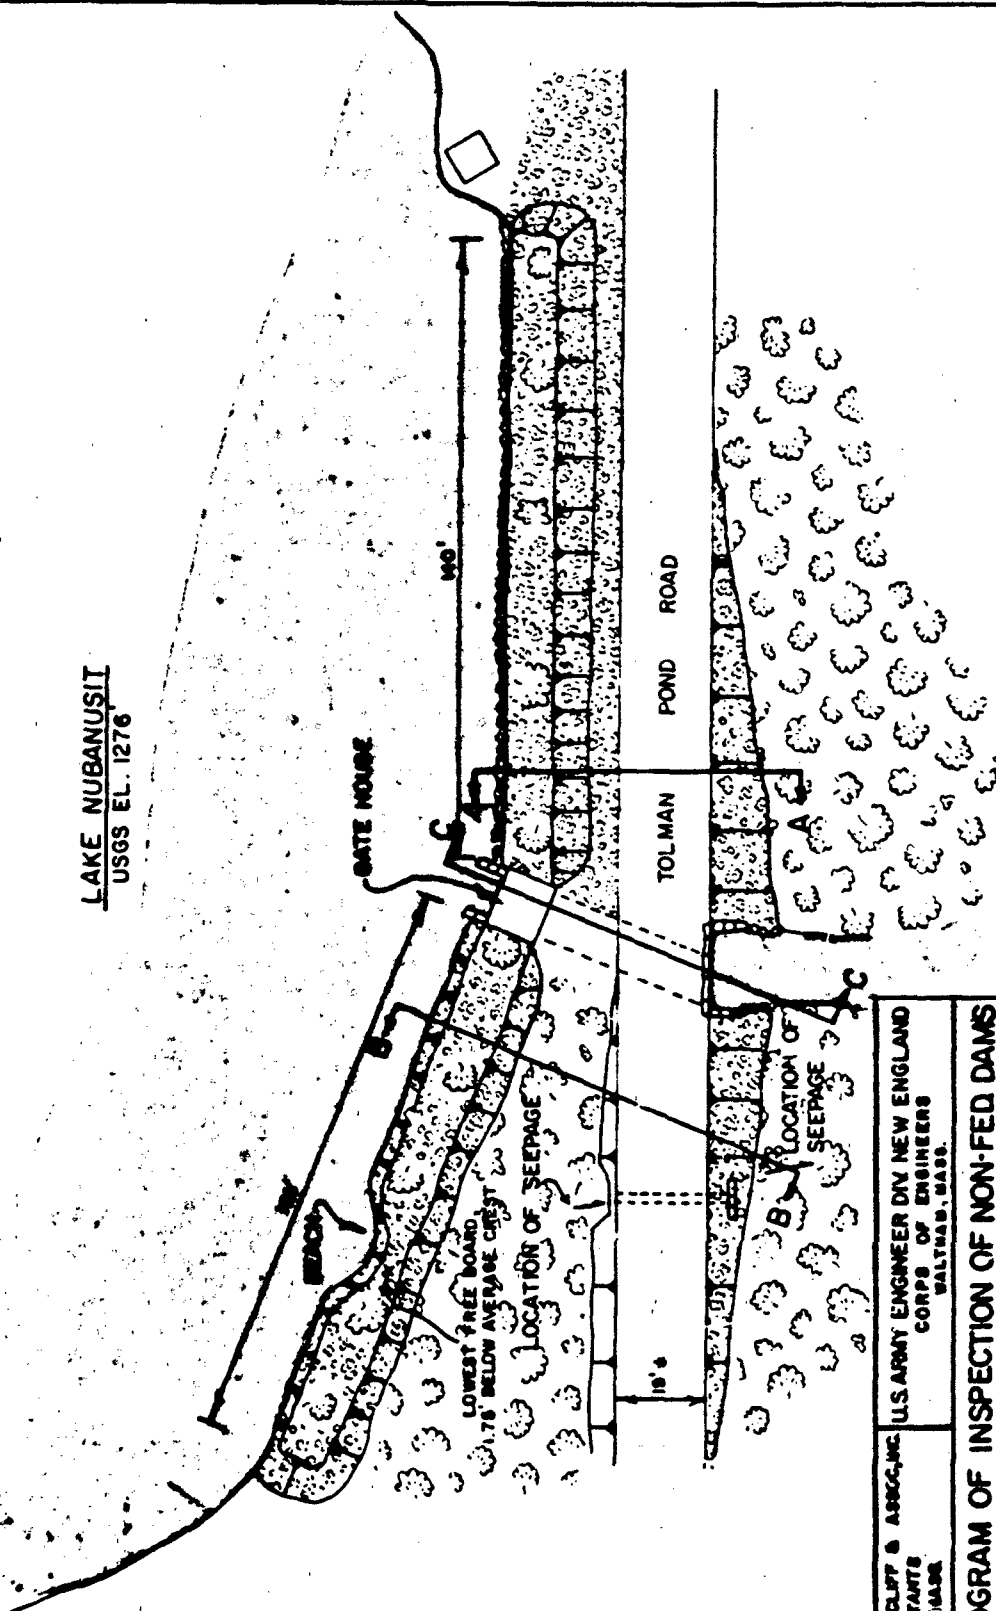
FIGURE 2

Inspection of the embankment revealed two low volume seepage points on the right side of the dam. As indicated in Figure 2 there is a 0.05 gpm flow of slightly discolored seepage at the toe of the right embankment near the inlet to a 16 inch culvert under Tolman Pond Road. The area is in the drainage ditch for the road, but the primary flow issues directly from the embankment. The second flow, of about 0.1 gpm, is across Tolman Pond Road and about 10 feet from the outlet of the culvert mentioned above. Since the general area of this seepage is also in an area through which surface drainage would flow, positive identification of the flow as seepage through the dam is not possible.

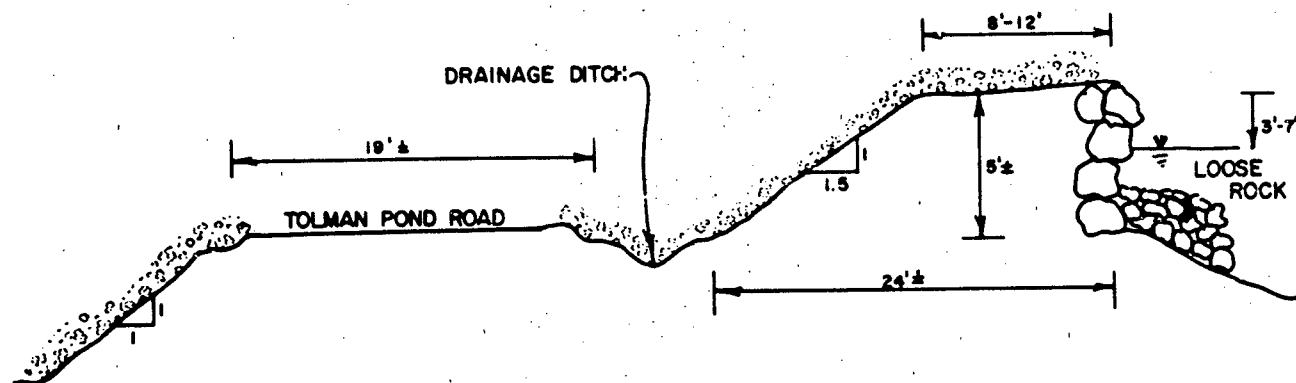
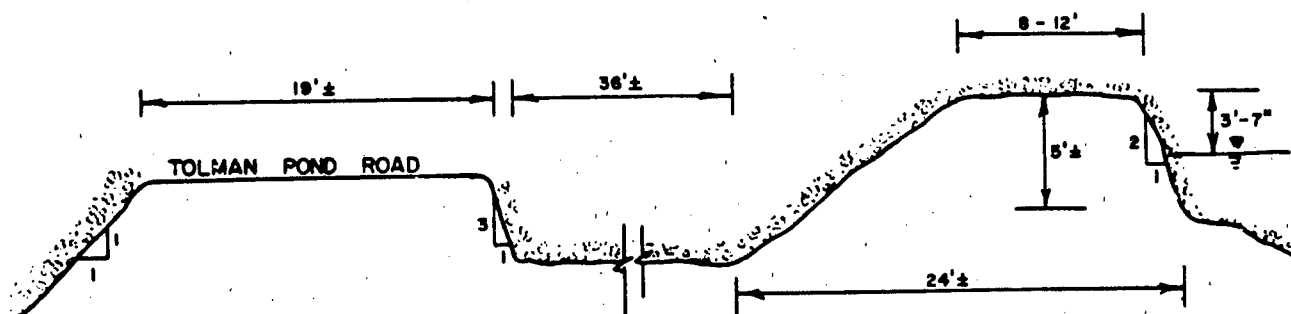
FIGURE 3

The granite spillway, although submerged, was visible due to the clarity of water and appears to be in good condition (Figure 3).
